# PRACTICAL PERCEPTION

## They've been called the "stairs of death"

Author: Dr. Donald H. Mershon

*Summary: Teaching a course in human perception can be even more fun, when it's possible to use local examples to illustrate one's presentation. The current topic discusses several independent sets of stairs in a university's libraries. Each case demonstrates the potential dangers of ignoring fundamental aspects of perception (such as the Gestalt Laws of Organization) and/or the science of human factors.*

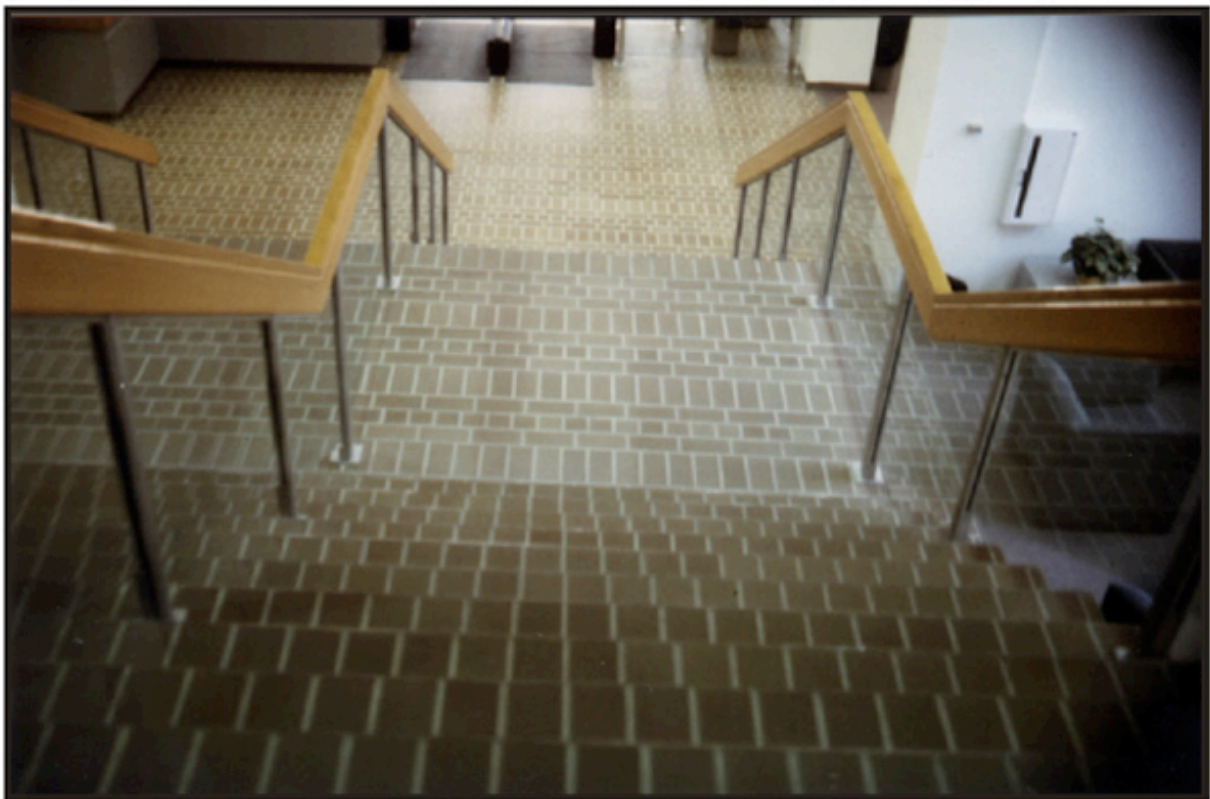
The original design of the new stairway included a surface of beige-colored tiles, oriented with their longer dimension perpendicular to the edge of the stairs' tread. If one approached the stairs from the upper-floor lobby, it was possible to be confronted with the situation shown in Figure 1. To varying degrees, the tile pattern made it difficult to distinguish the edges of the treads. In particular, the grout that separated the tiles could be readily perceived as continuous lines and there was little to emphasize the individual steps that one had to navigate, in order to safely descend the stairs. Even the intermediate landing and the floor below were constructed of the same tile, creating further confusion.

Figure 1  
Original appearance of the new stairs in the  
D. H. Hill Library (from above).  
Photo by author.

To some extent, ascending the stairs was also an issue. The individual steps were constructed with open-risers. That is, one saw not only the tread surfaces on which one wished to put one's foot, but also saw *through* the steps – and thus had to visually separate whatever had been stored behind/under the stairway. Of course, as from above, the grout lines on the stair surfaces themselves continued to "urge" a percept that camouflaged the edges of the treads.

In addition to the perceptual issues that did little for safe movement either up or down the stairway, there was also a basic human factors concern. The only handgrips along the sides of the stairs were made from a thick section of wood, positioned well above waist height. Although attractive, these rather high grips were difficult to grip well unless one was fairly tall, had a large hand and good grip strength.

Thus, as in so many situations that lead to accidents, many factors combined to set the stage. Perceptual factors that hid the edges of the steps (and/or distractions through the open risers, if one were ascending) could lead to awkward hesitations, to missteps and/or falls. Sadly, even if a walker recognized that he/she was in trouble, it was often difficult to fully compensate in time, given the design of the handrails.

While these stairs were in use, there were several reports of falls, including at least one broken arm and at least one concussion. Something had to be done.

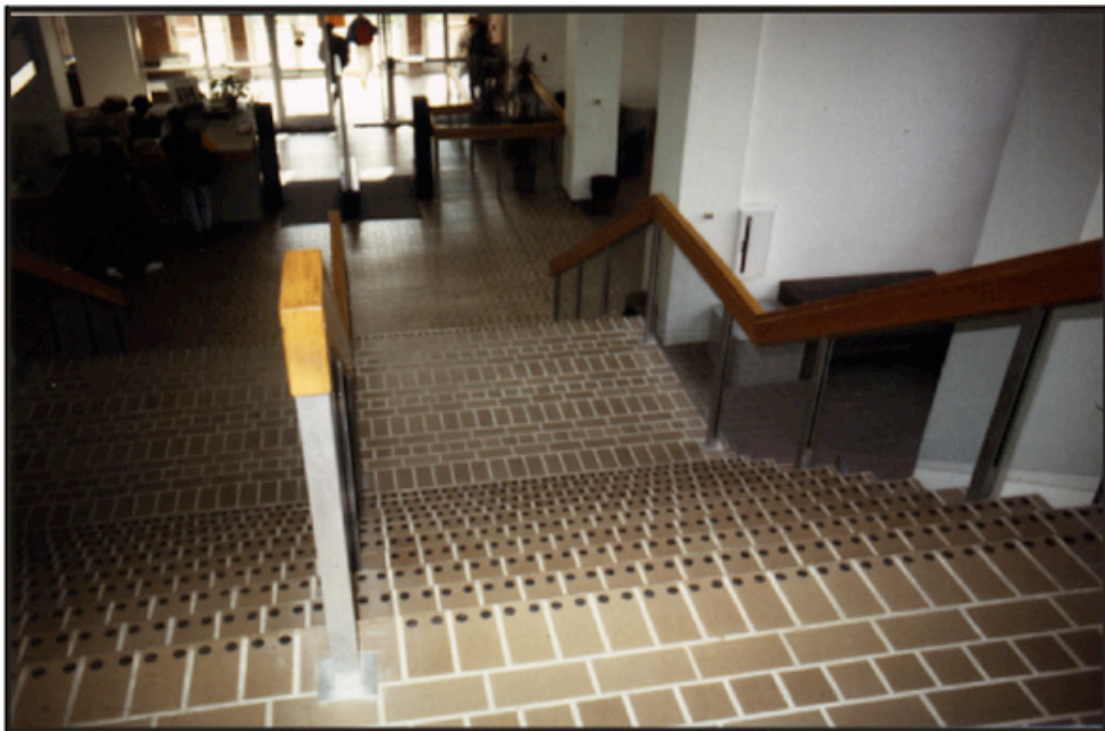
Unfortunately, as shown [Figure 2](#), the dots may have actually increased the fundamental problem. In addition to the effect of the unchanged, continuous grout lines, there was now a full field of dots that concealed the critical edge information even more effectively!

Figure 2  
Appearance of the modified stairs in the  
D. H. Hill Library (from above).  
Photo by author.

The first attempt to improve the dangerous stairs took a rather minimalist approach. No major modifications were done. Instead, rows of dots (of the sort ordinarily used to reduce slips in a bathtub/shower) were positioned along the front of each tread, apparently with the intent of better demarcating the front edges.

In human-factors terms, the dots also had a secondary effect – beyond the perceptual one already described. Such dots intentionally have a distinct surface texture, which assists in avoiding falls while bathing. That is to say, the surface of a dot was rougher than the surface of a tile.

Thus, when walking on the stairs, one might encounter either of two different kinds of traction. If your foot landed mostly on a tile, you would feel your foot move smoothly off the tread when you took your next step. In contrast, if you placed your foot directly on a dot, your foot would momentarily tend to stick. (Later, a colleague told me that the local building code did not approve stairs with contrasting surface qualities. I did not confirm this information, but it certainly would make sense.)

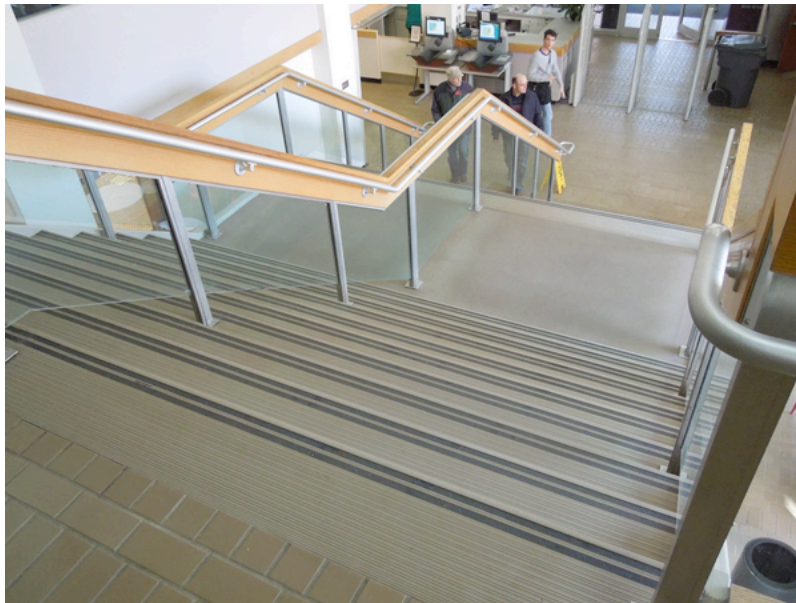
The rebuilt stairs (see Figures 3 and 4) finally handled the problems created by the first two attempts. The risers were now closed. There were *grip-able* handrails at a much more comfortable height. The front edge of each tread had a visibly different appearance than the rest of the tread. And the tile/grout surface was no longer present. To the best of my knowledge, accidents decreased to whatever would be the norm for any often-used public stairway.

Figure 3  
Appearance of the fully rebuilt stairs in the  
D. H. Hill Library (from above).  
Photo by author.

Eventually, the entire stairway area was walled off. Library visitors were all directed to the elevators. The old (new?) stairs were removed and a completely redesigned stairway was built. The process took 6-9 months, before access to the stairs was again permitted.

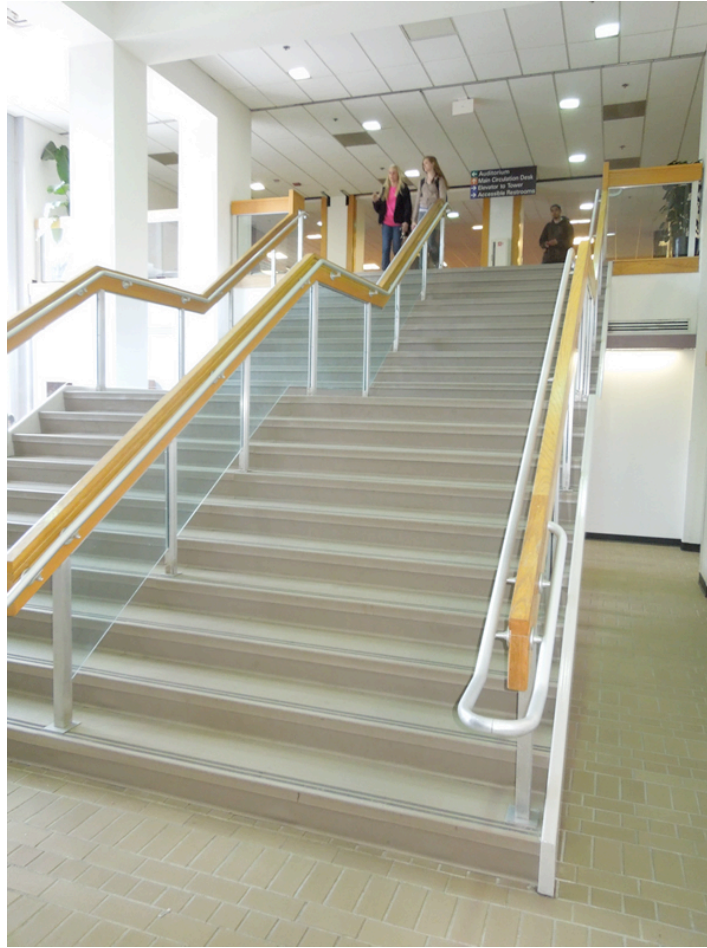
Figure 4  
Appearance of the fully rebuilt stairs in the  
D. H. Hill Library (from bottom).  
Photo by author.

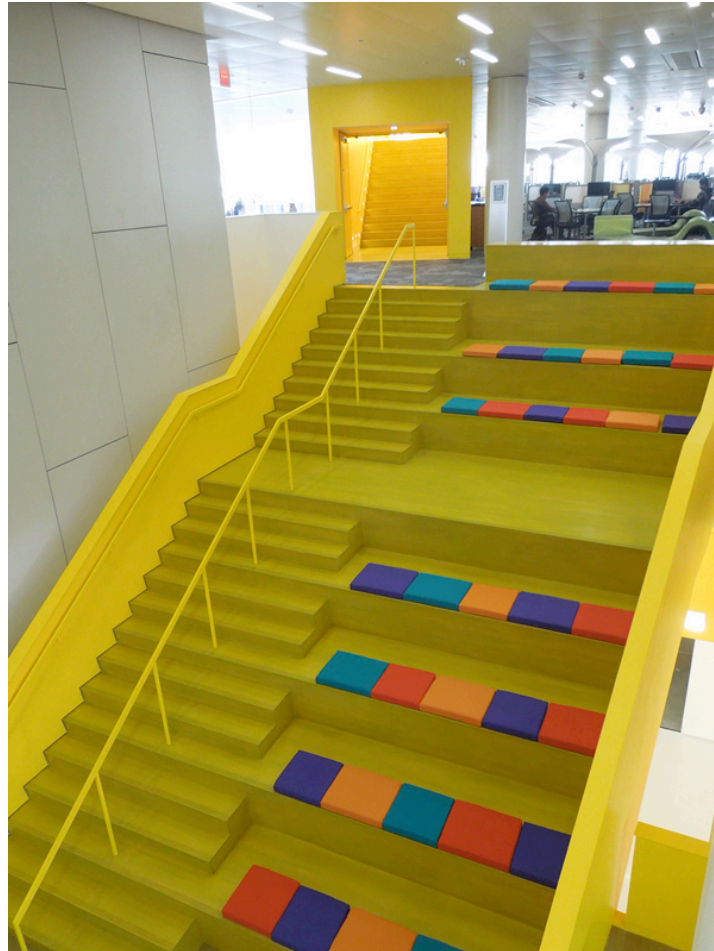
The stairways of the new library, although quite colorful were – unfortunately – much too reminiscent of the earlier stairways discussed above. Figure 5 shows a view from above one of the new stairways. Figure 6 provides a view from the bottom of another stairway in the same library.

Figure 5  
Appearance of a stairway and sitting area in the  
J. B. Hunt Library (from above).  
Photo by author.

I will leave it to the reader to decide whether a study of perception and of human factors would support the architectural choices shown. Note in particular the similar, even if not identical, yellow on the stairs themselves, as well as the areas beside them. Note also the lack of any railing within grabbing distance, if you happen to misstep while descending. (Now add the consequences of a momentary distraction upon seeing a friend seated on a cushion beside the stairs. Consider how the possibility of a bad outcome might increase if one were descending the stairs of Figure 5 while carrying a load of study materials and/or a laptop.)

Since my visit, I have learned that at least some library staff members themselves call these new stairs the *Stairs of Death*. I will update this article, if the university decides to re-paint or redesign this aspect of the new facility. Meanwhile, I will hope my expectations are perhaps too pessimistic.

In late summer of 2015, the university did decide to repaint the stairways in the Hunt Library. A brief article about the paint freshening appeared in the local newspaper. And what is the stairways' "new" color? You guessed it – Yellow!

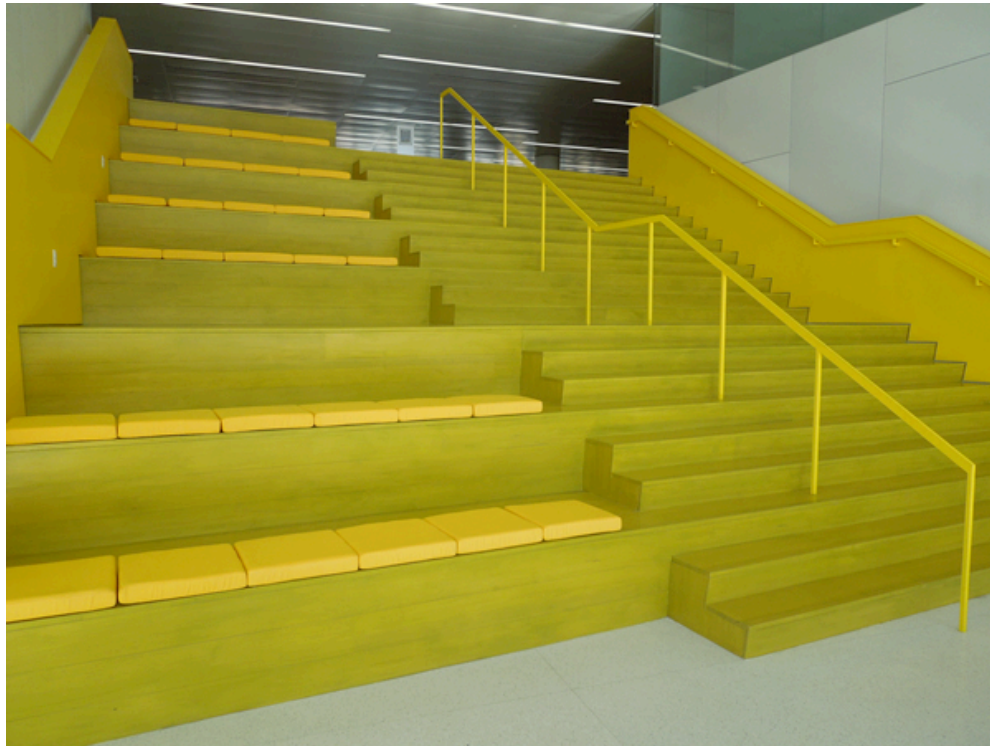
Figure 6  
Appearance of a second stairway and sitting area in the  
J. B. Hunt Library (from below).  
Photo by author.
